**DECLARATION OF AMIT OZA  
IN SUPPORT OF DEFENDANT'S  
MOTION FOR COUNTER-SECURITY**

- 1.3 The matter concerns the collapse of No. 1 crane of the "RISHIKESH" which unfortunately resulted in the death of the crane operator. The "RISHIKESH" is a 5 hold bulk carrier with five cranes. No 1 crane is located on the foc's'le and is manufactured by M/s Brissonneaux & Lotz Marine (BLM), France.

6184/CM/DH  
"RISHIKESH"  
Page 1 of 38

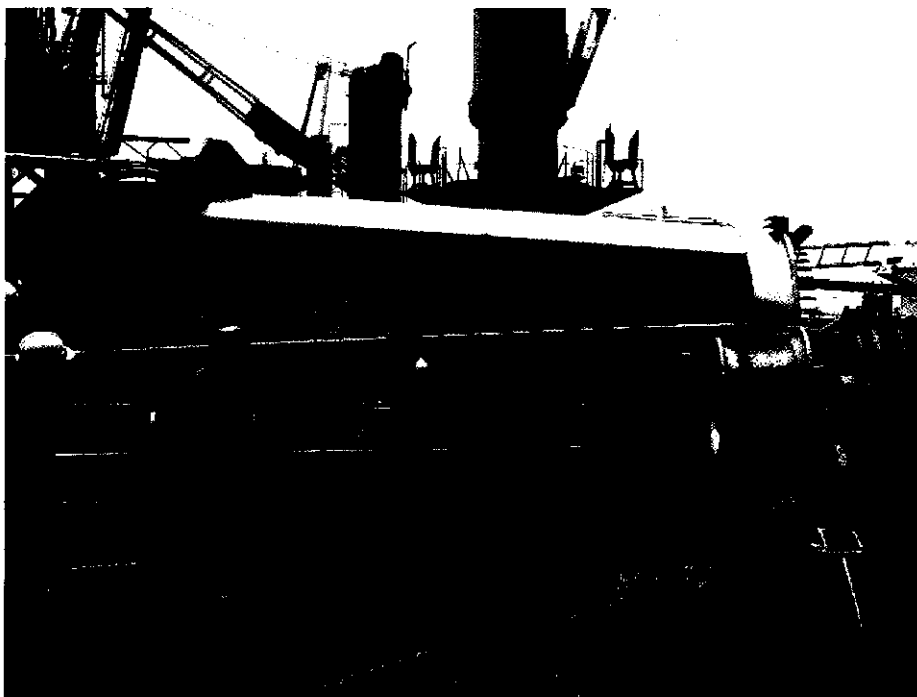
Figure 2, General view of crane tower

- The crane tower is shown lying on top of No. 1 hatch cover, **Figures 1 to 5**. It can be seen that many of the stud joints have failed and part of the outer slewing ring race has fractured.
- The fractured part of the outer ring of the slewing bearing, **Figures 6 to 8** showing the respective fracture surfaces.
- The pedestal and inner slewing ring remaining in place, **Figures 9 to 11**. Note that the pedestal appears to be completely unaffected and free of any distortion or deformation.
- Numerous nuts, washers, roller bearings and spacers scattered on the crane platform, **Figures 12 and 13**.
- The open grab bucket on the quayside, **Figure 14**.
- The buckled crane jib, **Figures 15 and 16**.
- The parted runner wire, **Figure 17**.

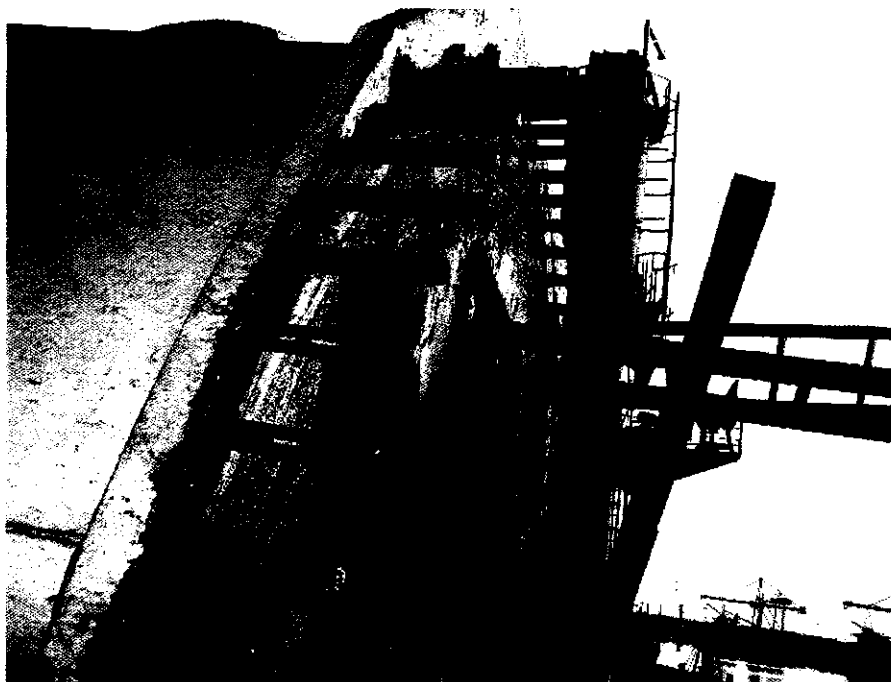
**Figure 5, Close-up view of crane tower showing some of the failed stud joints in way of area of fractured slewing ring.**

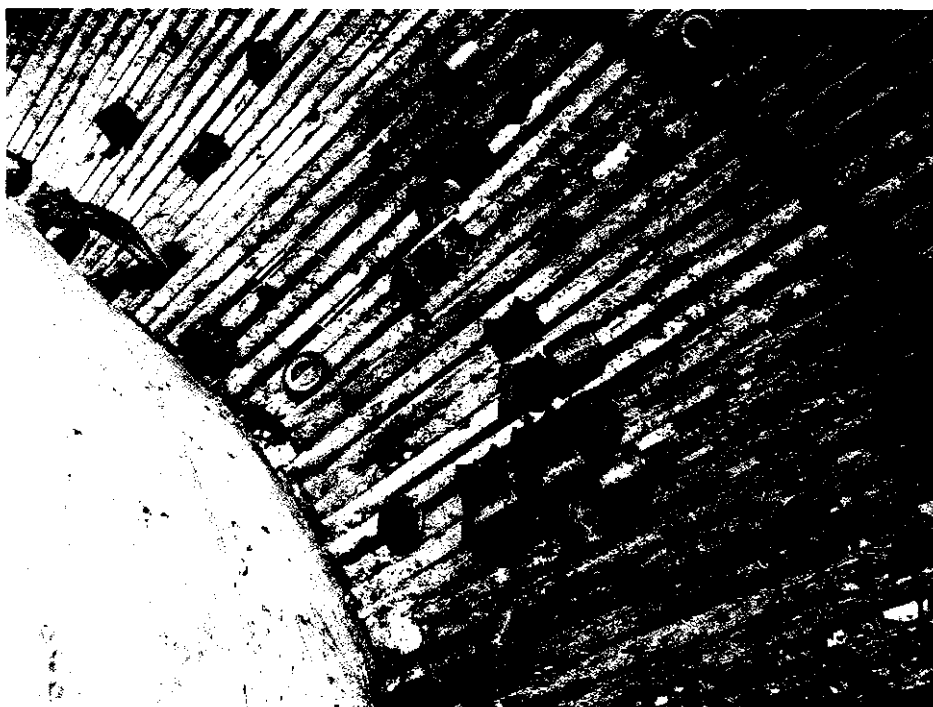
Figure 12, Numerous nuts, washer, bearing and spacers on the crane platform

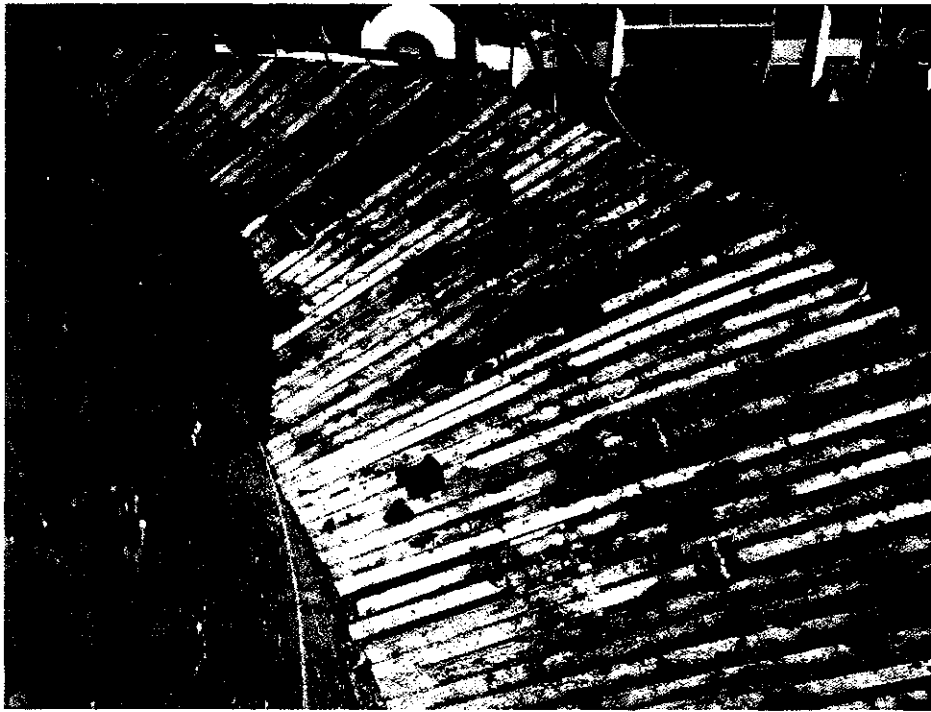
Figure 13, Numerous nuts, washer, bearing and spacers on the crane platform

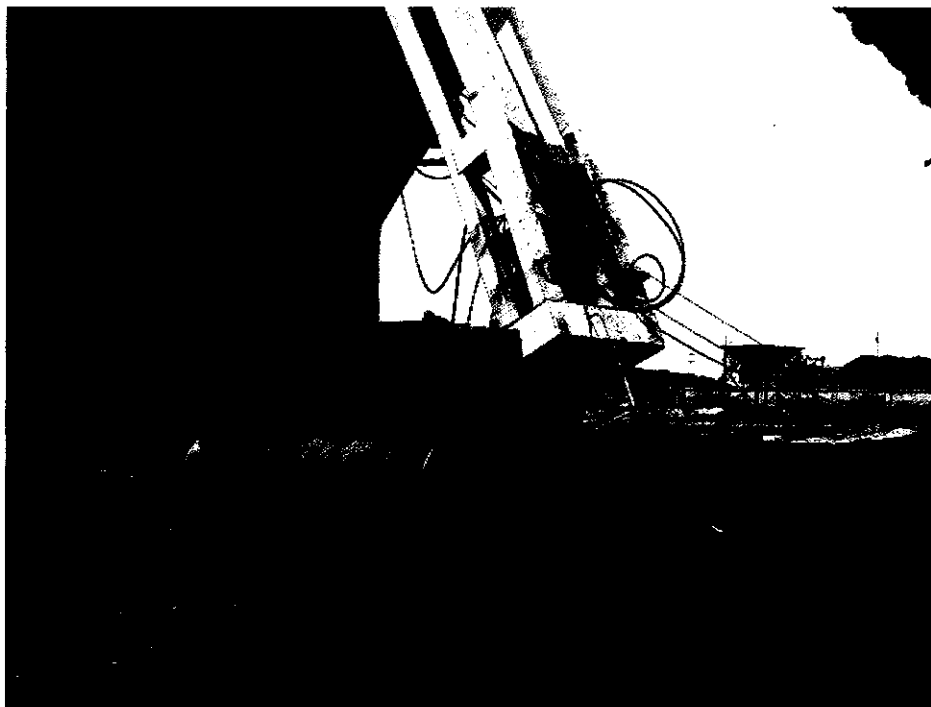
Figure 14, Open grab bucket on quayside

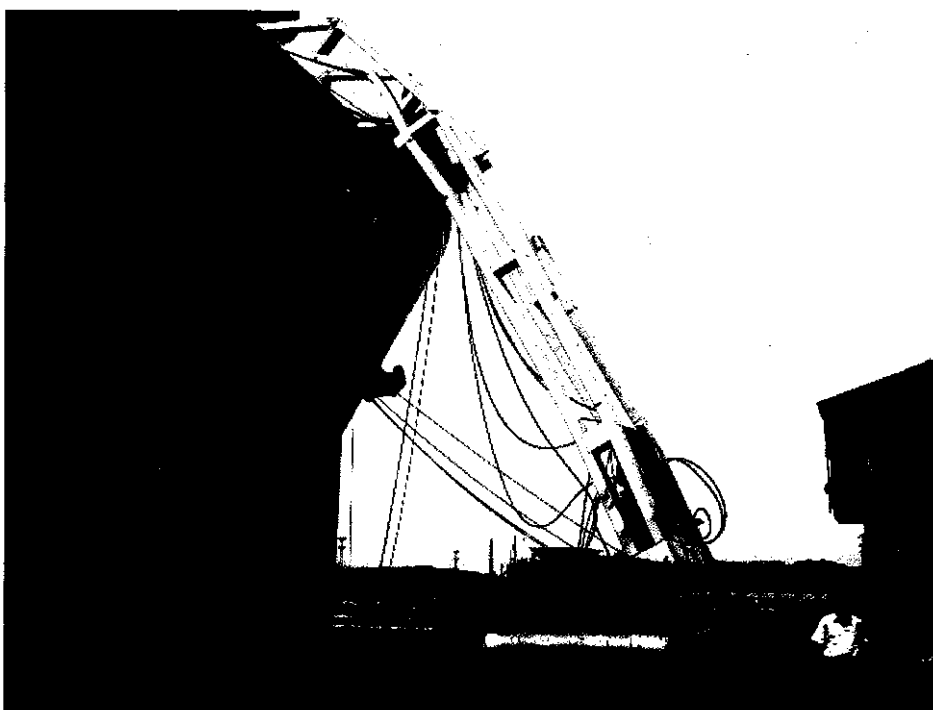
Figure 15, Buckled crane jib

Figure 16, Buckled crane jib, note little or no damage to the bulwarks

3.2 Thus the crane has simply toppled over. The jib position was reported as being at about 45° to the crane tower at the time of the incident. There is no damage to the ship's bulwarks confirming that the jib must have been at a reasonable angle or the jib would have made significant contact with the bulwarks before the crane tower hit the hatch covers. Therefore the only feasible toppling forces have been normal toppling forces that should normally be resisted by the crane's structure. Therefore the crane's structure must have been weak to allow the crane tower to topple whilst not under any extraordinary loading. The slewing ring studs are designed to withstand the toppling forces.

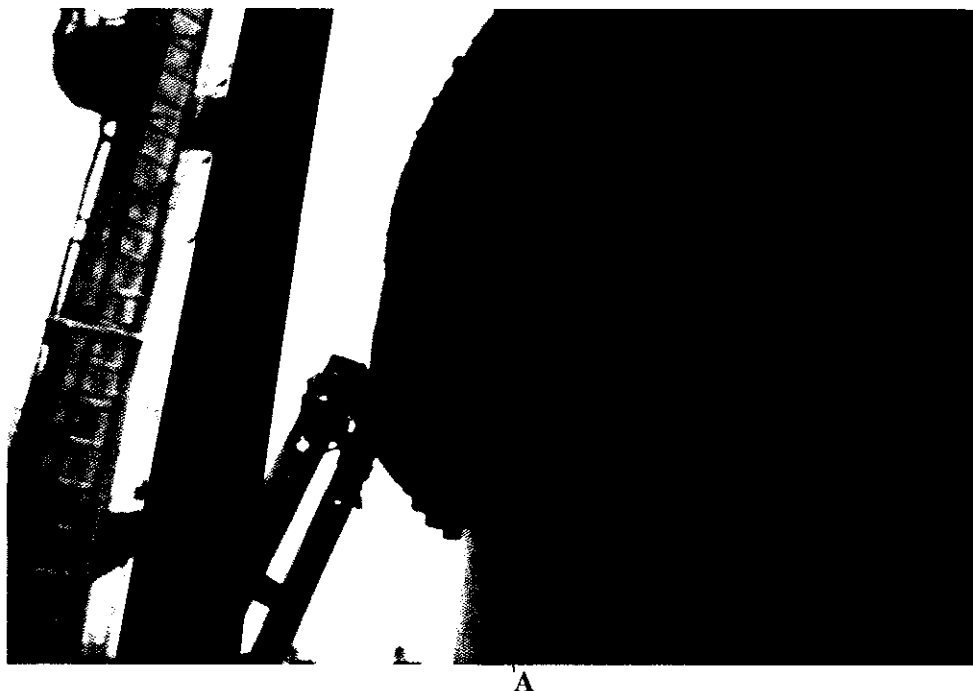
- 2.6.2 **Figure 20** shows some of the studs used on the lower flange to inner race joint. There was a significant crack in the paint in way of one nut/washer, see **Figure 21**, which could be indicative of a loose nut.

Figure 20, Close-up view of some of the lower flange stud joints, the paint is cracked around one of the joints, indicated by arrow 'A' and see Figure 21 below

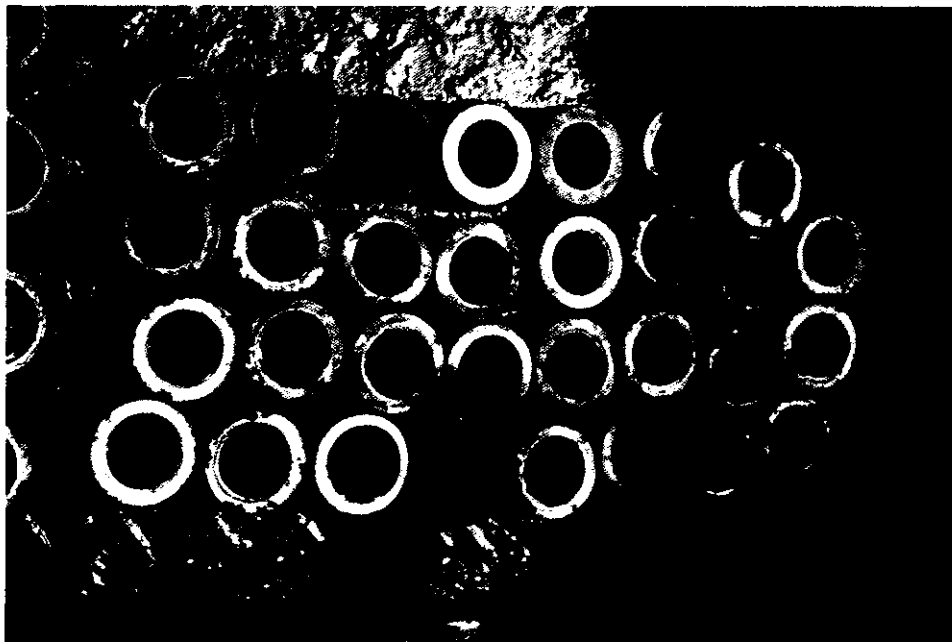
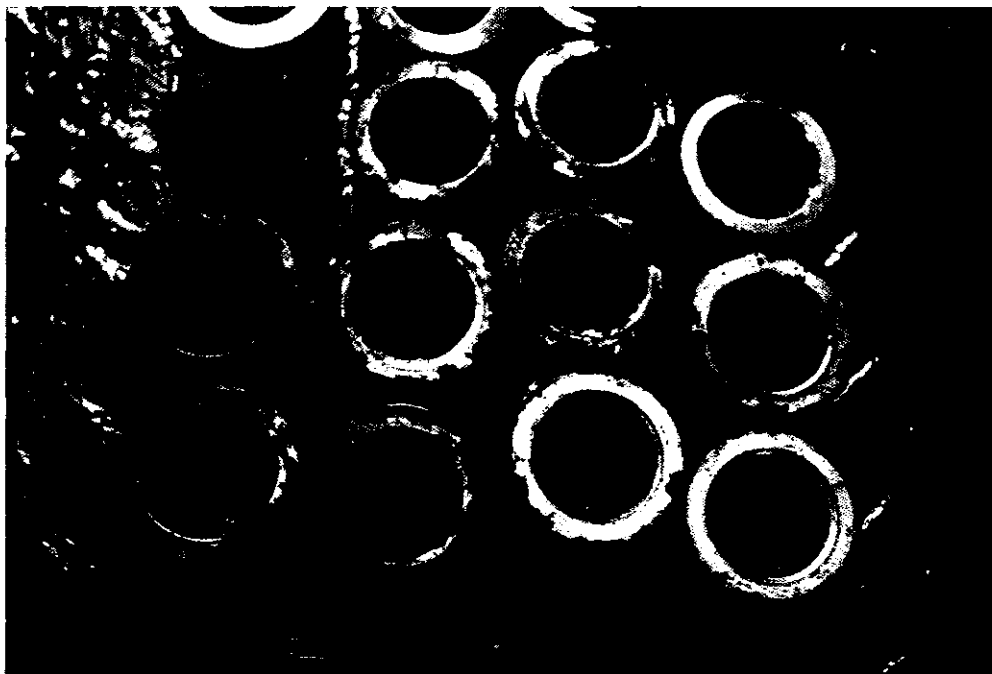
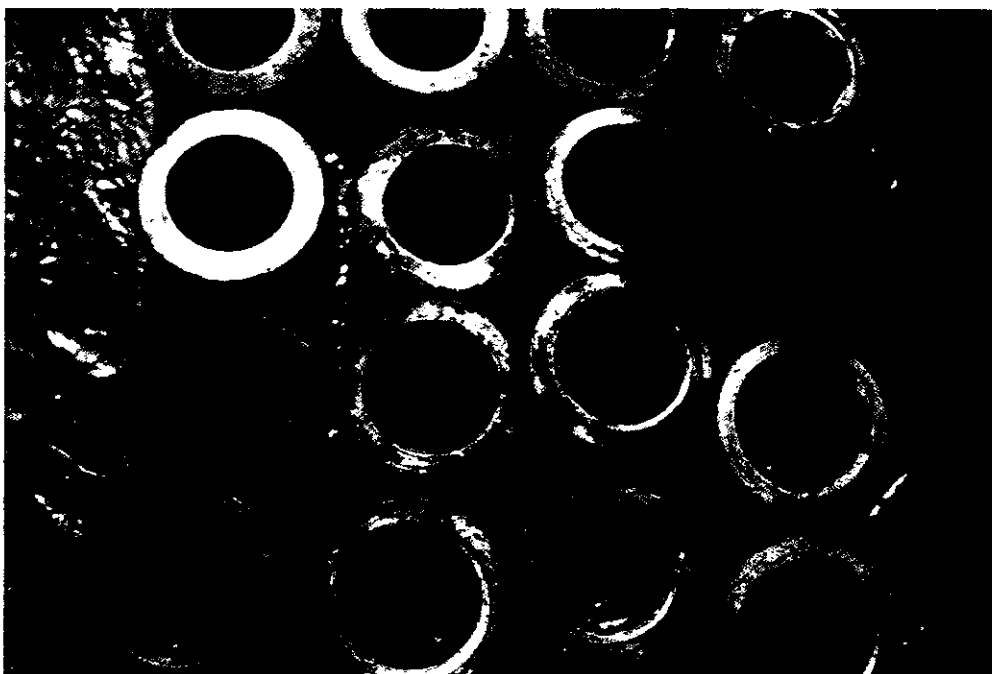
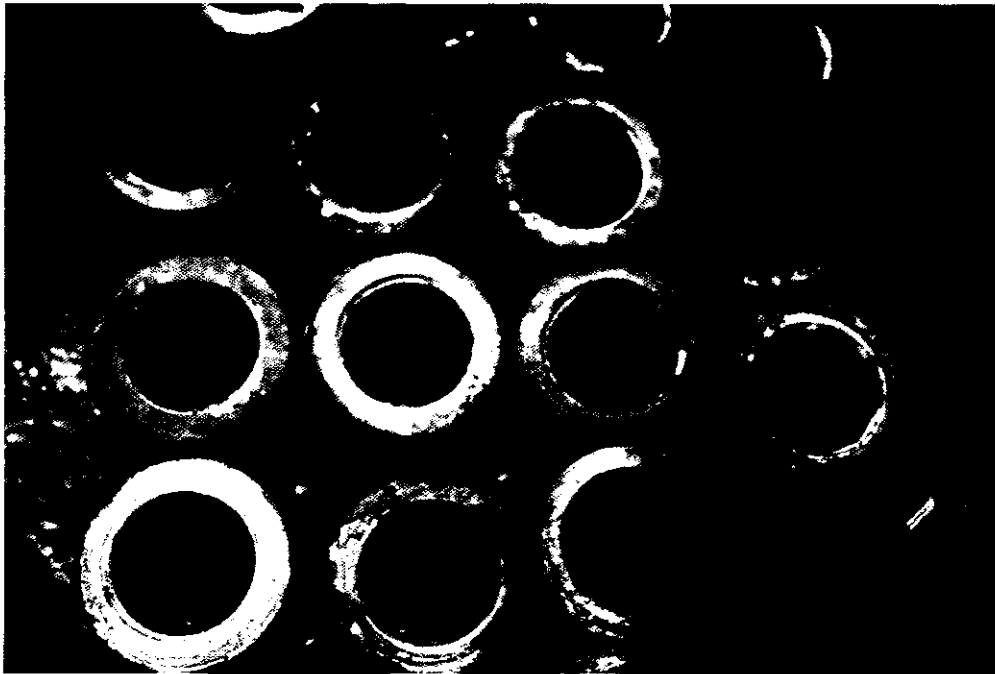
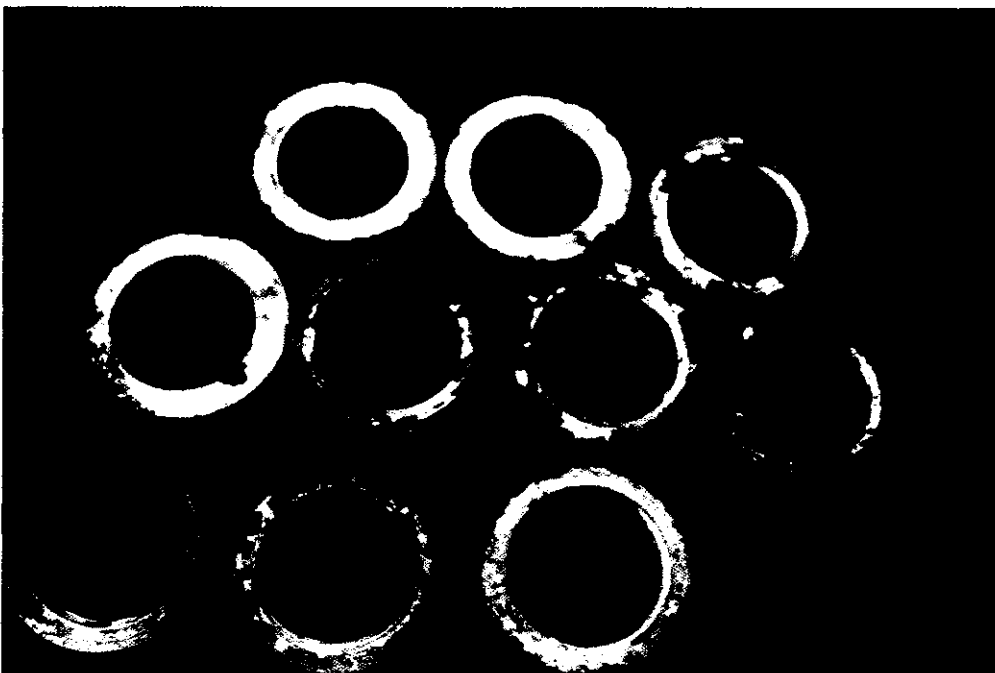
- 2.7.2 **Figures 23 to 27** show the same nuts but turned over to show the face that would have been in contact with the washer. Again rusty threads can be seen. It may also be seen that there is significant variation in the condition of the contact surface ranging from bright to rusty. A rusty surface is indicative of a loose nut as the presence of rust indicates that water has been able to penetrate between the mating surfaces which would not be possible if the nut had been fully torqued up.

Figure 23, General view of the same nuts showing the contact surface. A variation of bright to rusty contact surface can be seen

**Figure 24, Close-up view of some of the nuts showing the different visual appearances. The bright areas appear to be a coating of some nature, probably zinc (galvanised)**

**Figure 25, As for Figure 24**

Figure 26, As for Figure 24

Figure 27, As for Figure 24

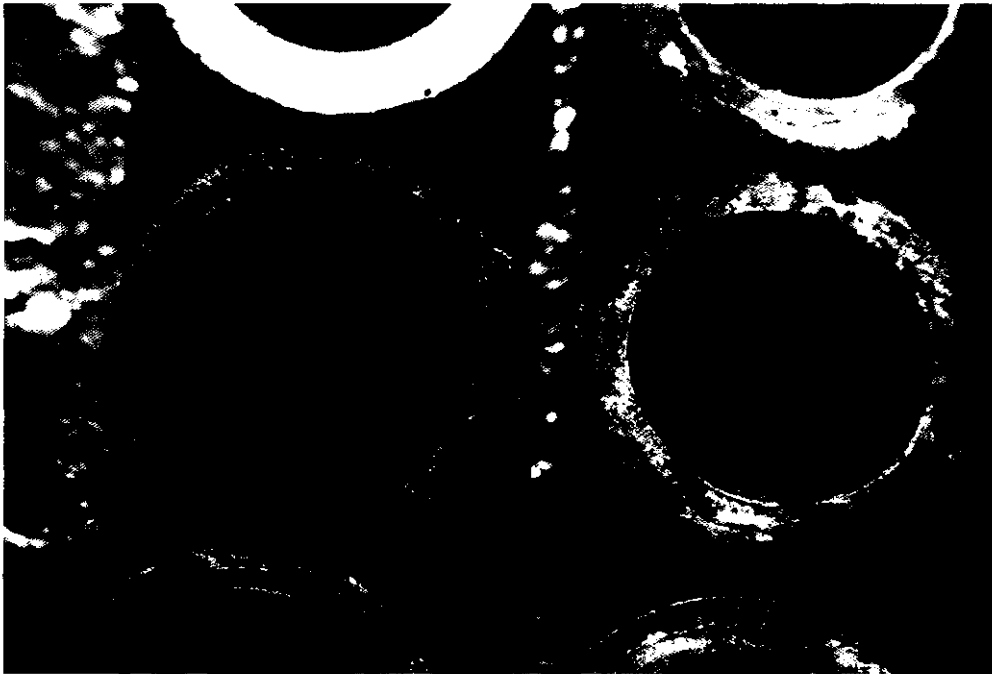
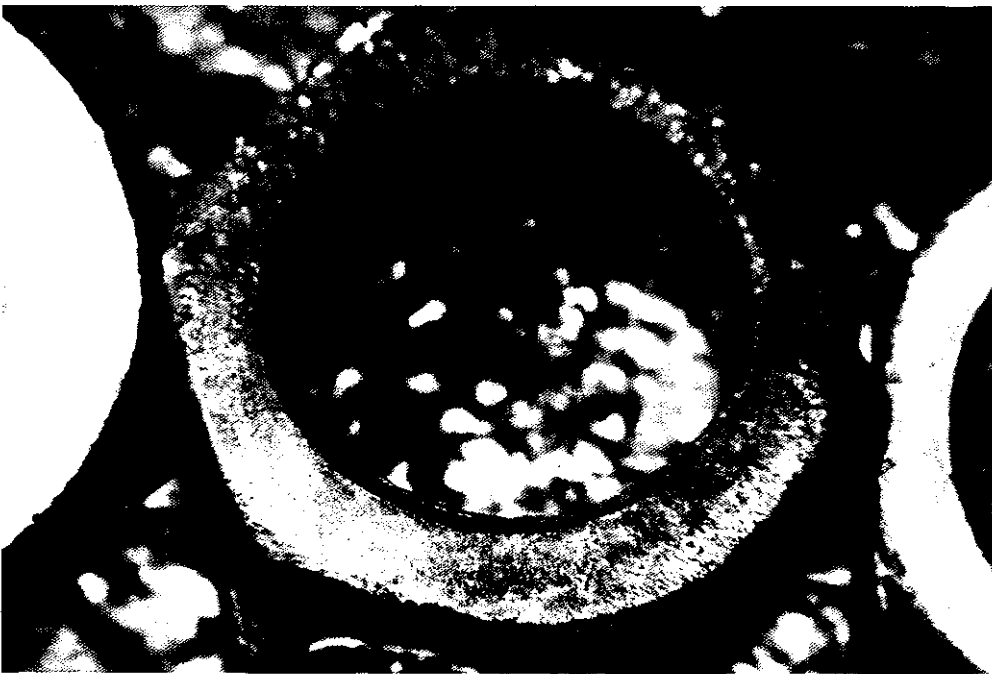
- 2.7.3 **Figures 28 and 29** show some of the rusty nuts and **Figure 30** shows the bright surface evident on some of the other nuts. I was of the opinion that the bright surface was in fact a coating, possibly zinc, indicating that the nuts may have originally been galvanised.

Figure 28, Close-up showing a heavily corroded contact surface indicative of the joint being loose for some considerable period of time.

Figure 29, Similar to Figure 28

were corroded. This is indicative that a significant number of stud joints were not tight such that water was able to enter the respective joint causing corrosion of the contact surfaces. The extent of corrosion on some of the items was severe indicative of long term exposure and thus the joint must have been loose for a long period of time measured in months and years.

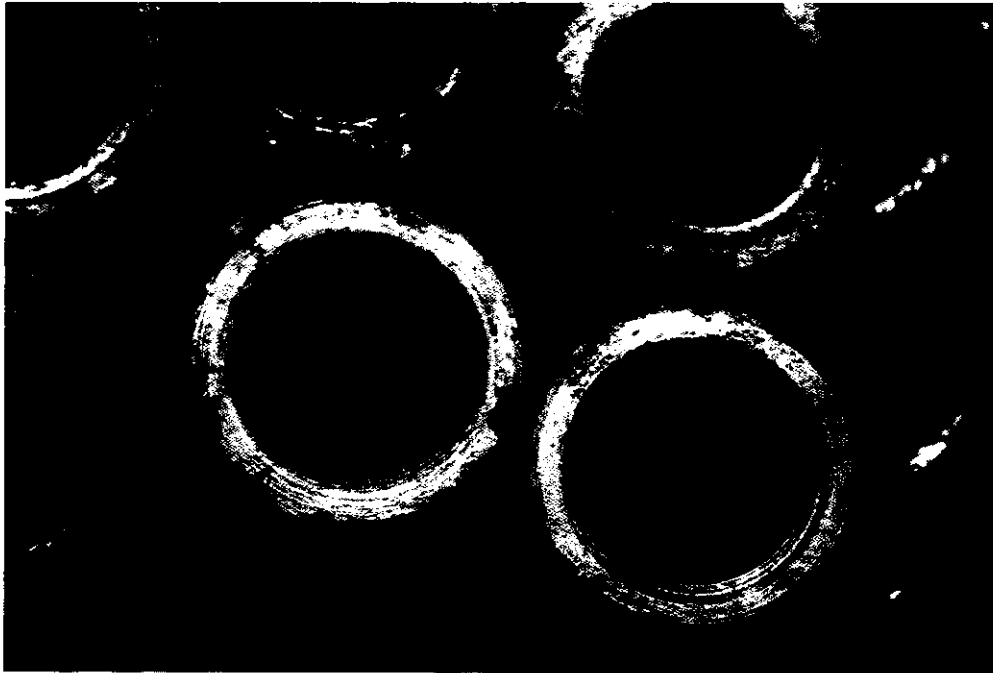
**Figure 30, Close-up view of some nuts showing probable breakdown of the plating**

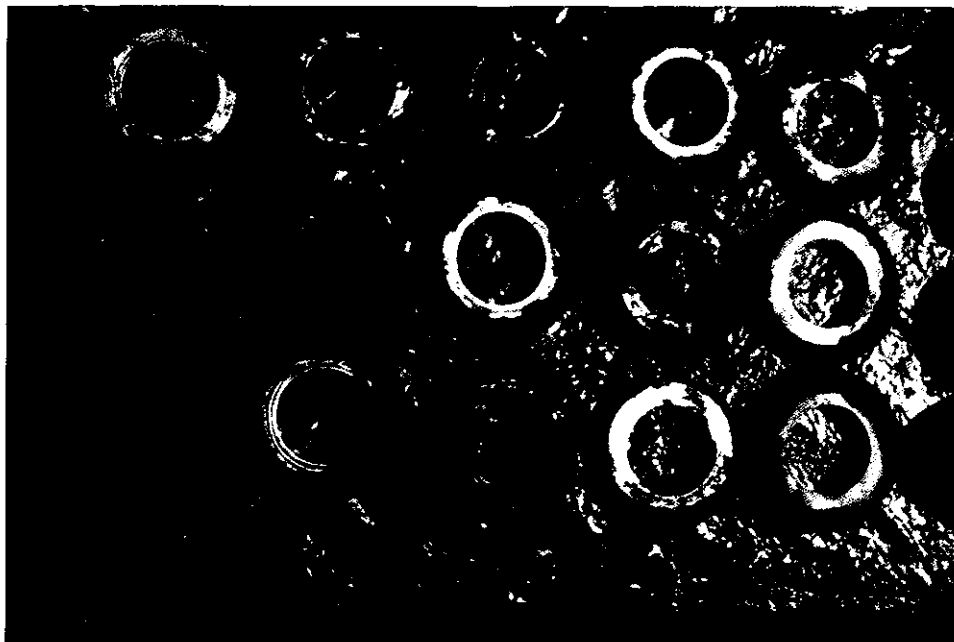
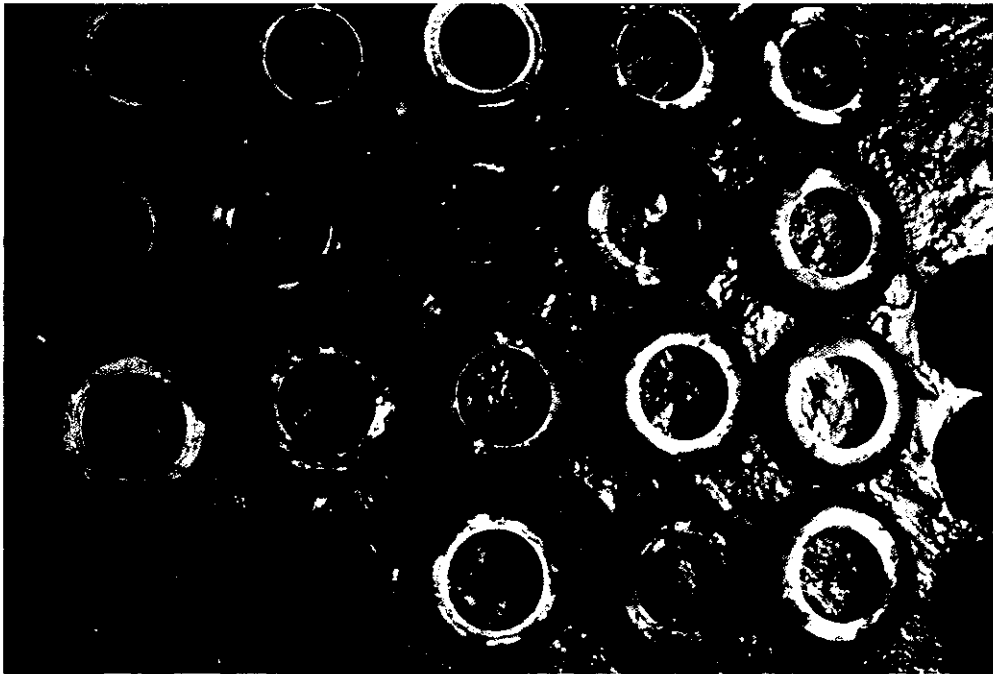
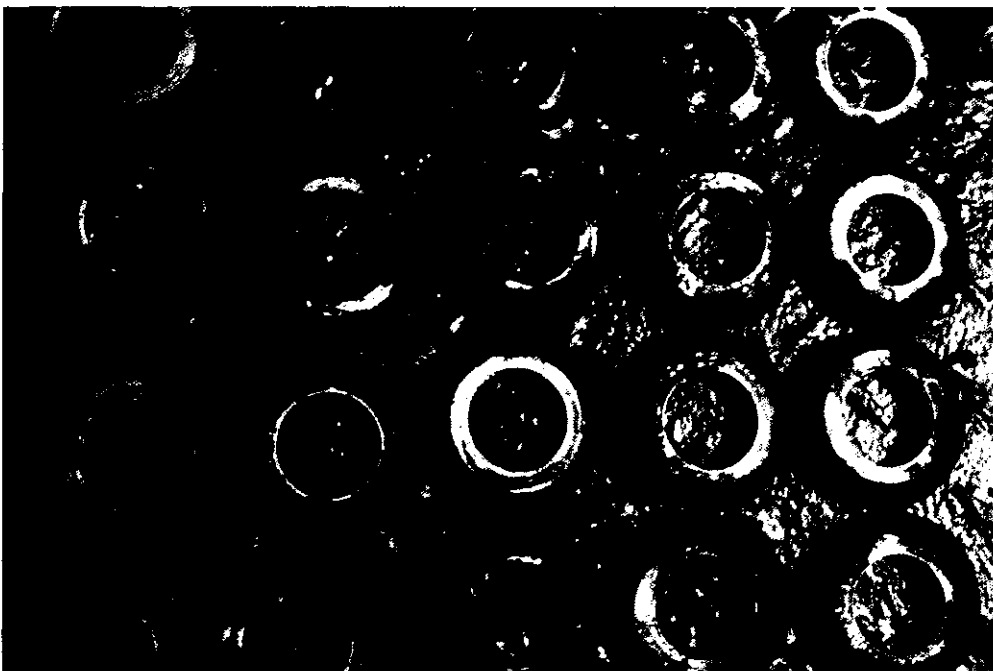
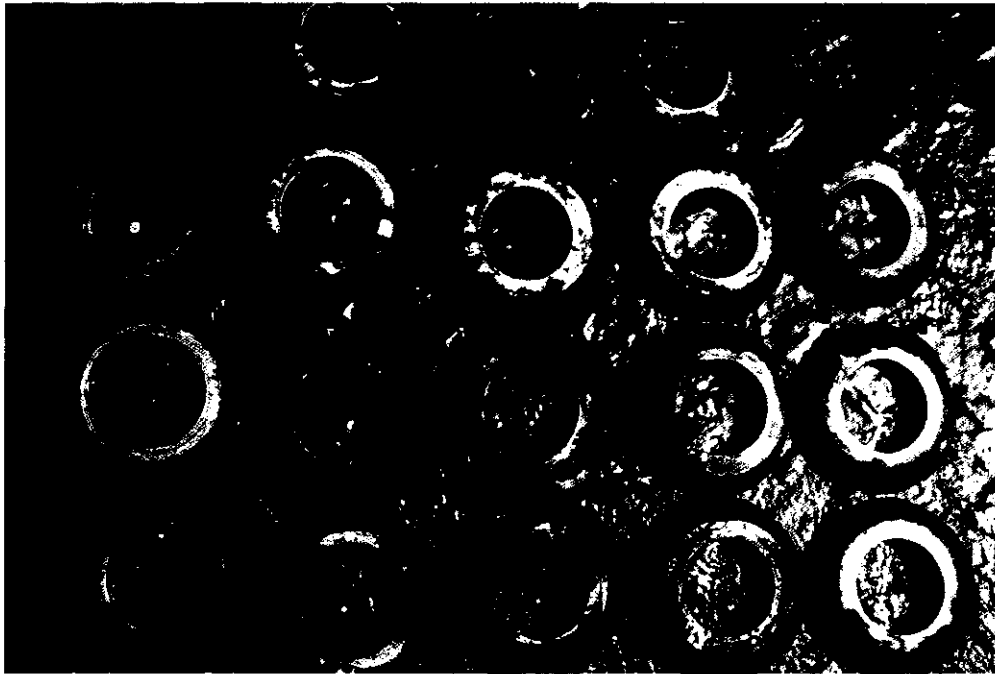
- 2.8.1 **Figure 31** shows the 45 washers with the surface that would have been in contact with the nut visible. Closer views of the washers are shown in **Figures 32 to 36**. Again a significant variation in the appearance of the washers can be seen ranging from a fully rusty contact surface to a bright surface. Again these washers appear to have been plated, probably galvanised. Closer views of some of the washers are shown in **Figures 37 and 38** showing severe rusting of the contact surfaces.

**Figure 31, General view of some of the washer showing the surface that would have been in contact with the nut. A large variation in the appearance from bright to rusty can be seen.**

**Figure 32, Close-up view of some of the washers showing the different visual appearances. The bright areas appear to be a coating of some nature, probably zinc (galvanised)**

Figure 33, Similar to Figure 32

Figure 34, Similar to Figure 32

Figure 35, Similar to Figure 32

Figure 36, Similar to Figure 32

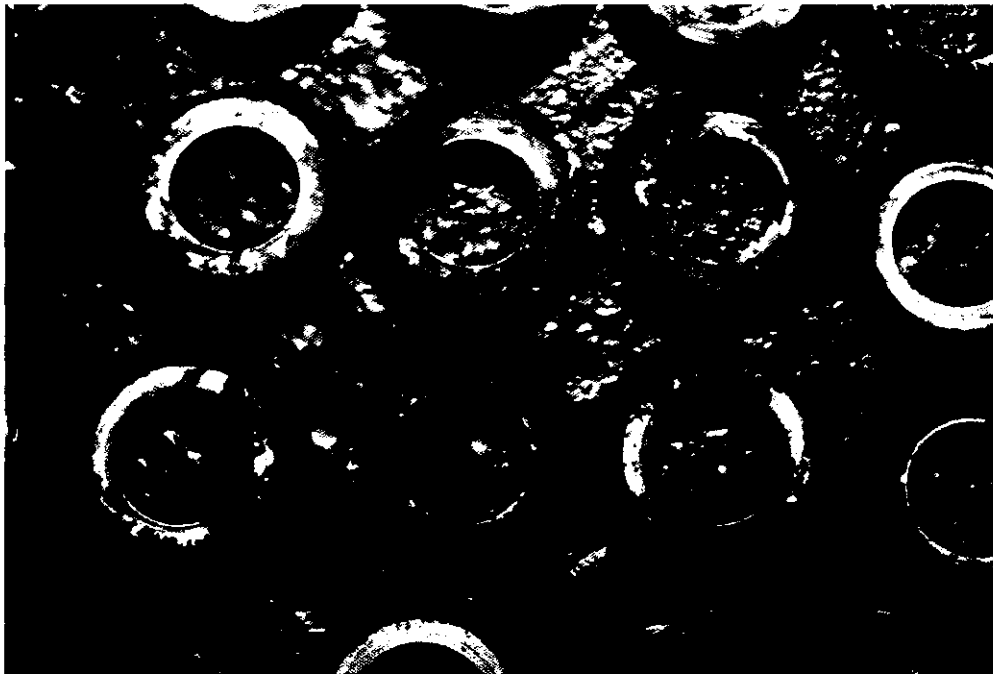
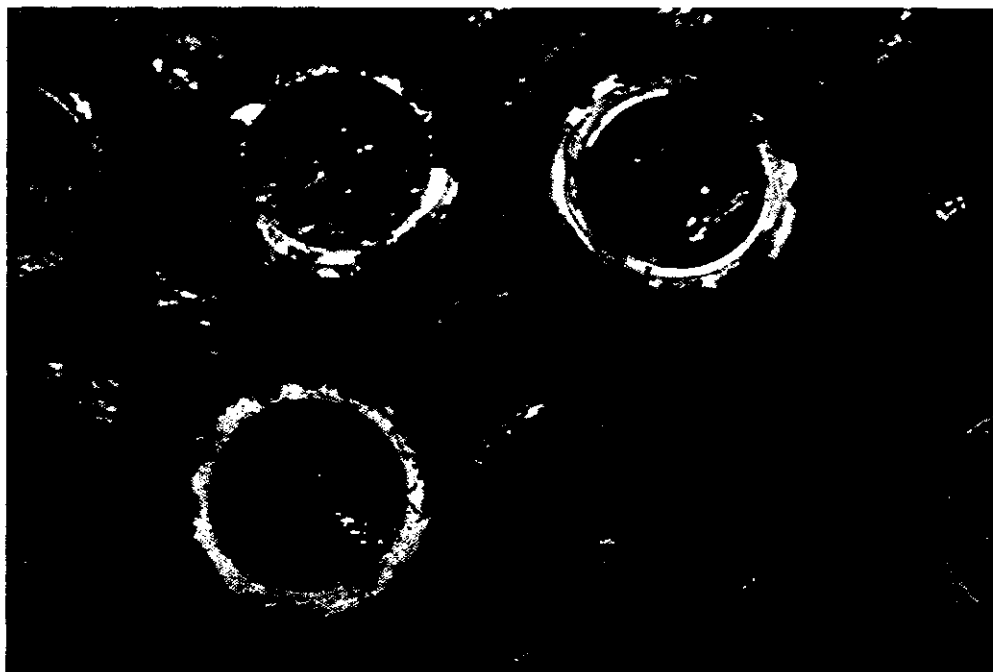
Figure 37, Closer view of some of the washers showing severely rusted contact surfaces.

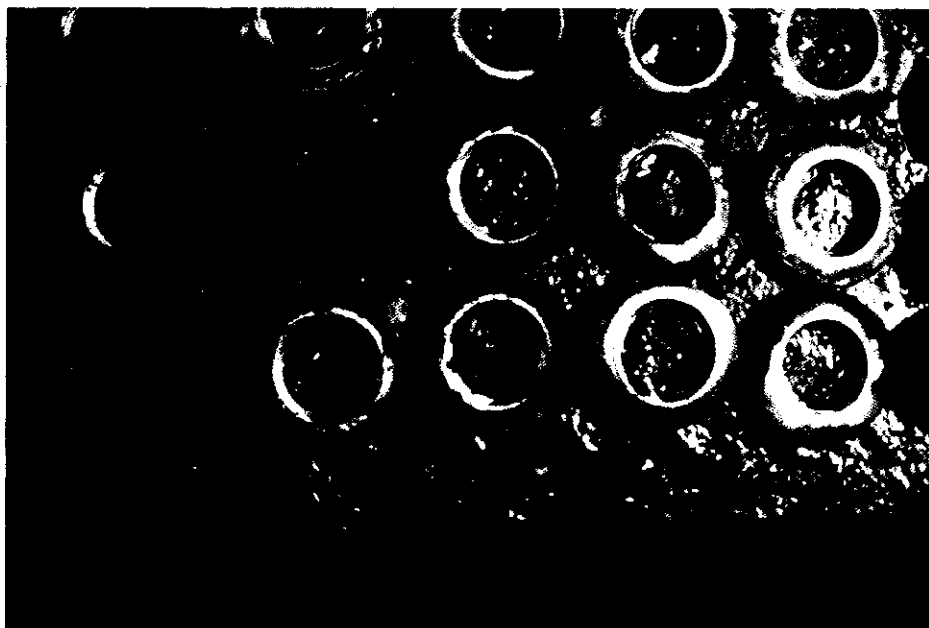
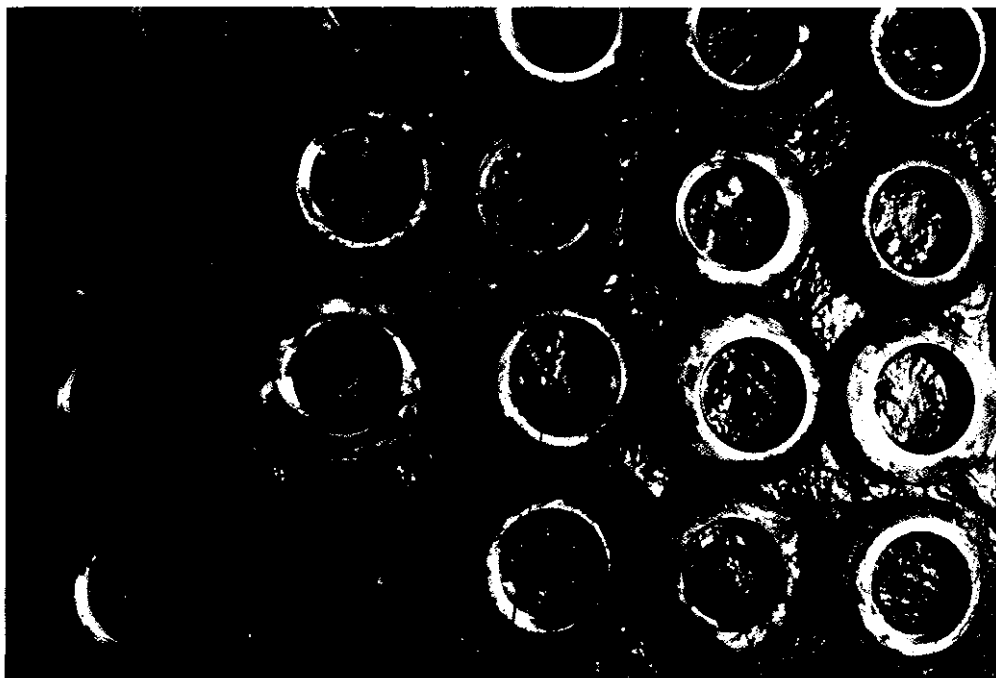
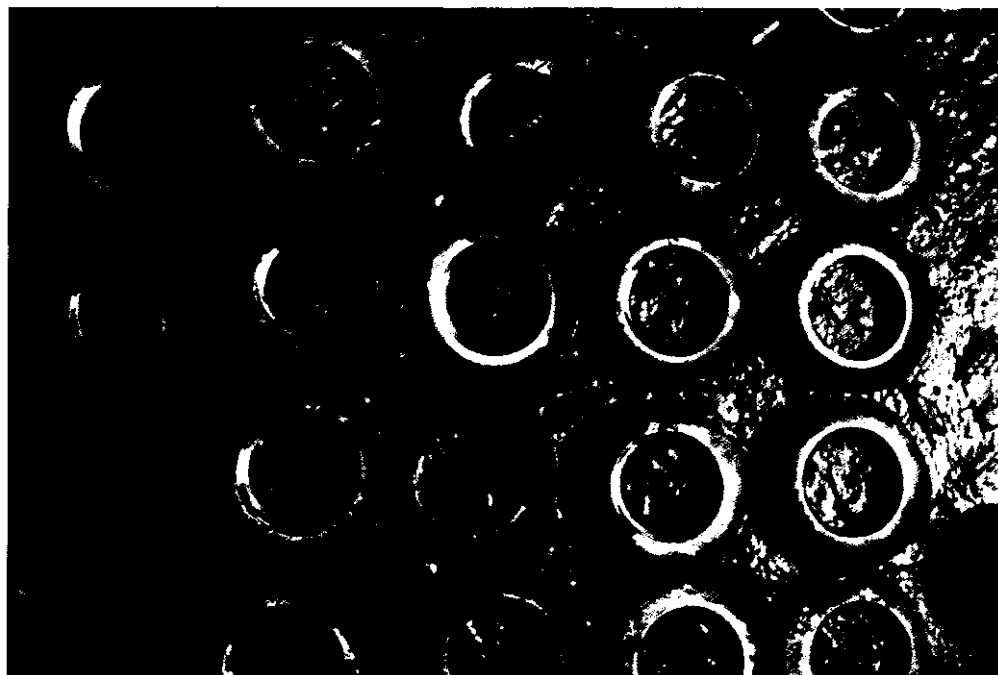
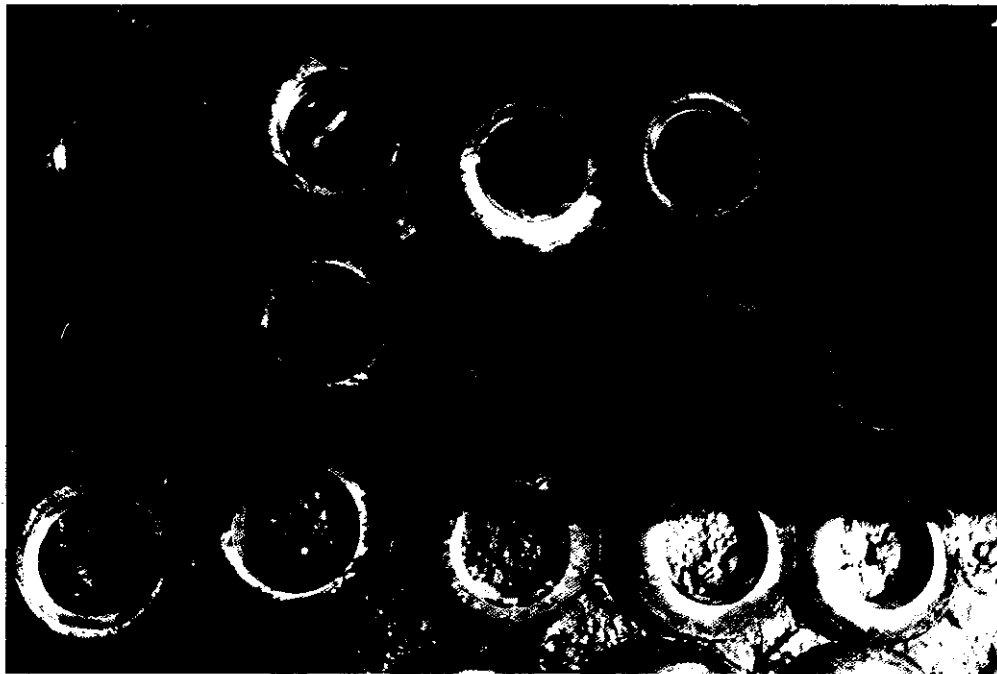
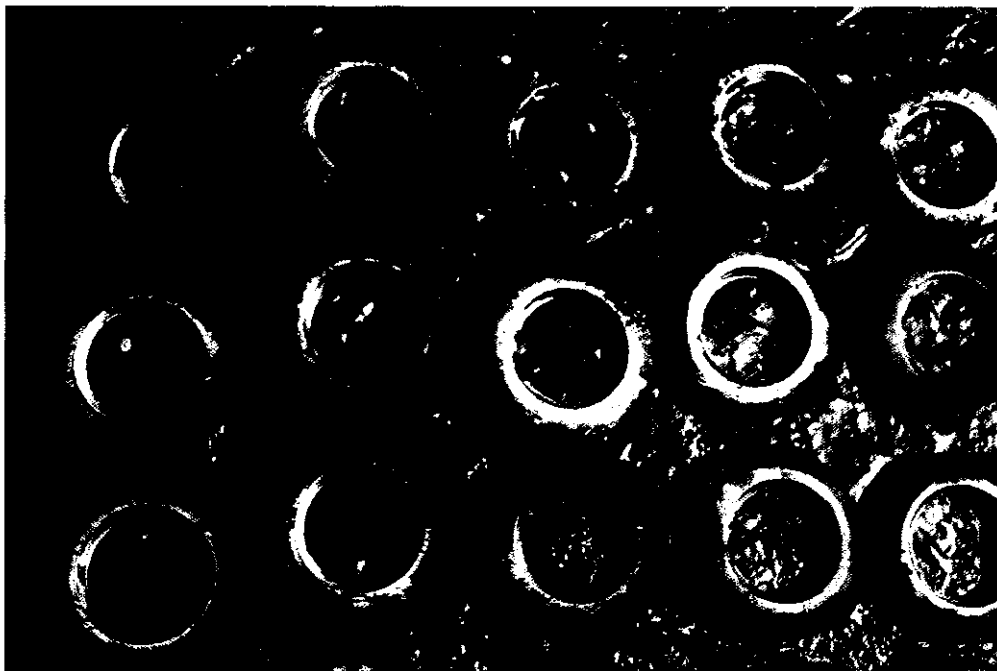
2.8.2 The surface of the washers that had been in contact with the outer slewing ring race are shown in **Figure 39** with closer views shown in **Figures 40 to 44**. Again a significant and large variation in the condition of this contact surface can be seen on these washers. It may also be seen that a number of the washer are not 'round' but had an irregular shape. Further the bore of the hole on this surface has been chamfered. **Figures 45 and 46** are closer views showing some of the features mentioned above.

**Figure 39, General view of some of the washers showing the surface that would have been in contact with the slewing ring. A large variation in the appearance from bright to rusty can be seen. Note the bore of the washer has been chamfered.**

**Figure 40, Close-up view of some of the washers showing the different visual appearances. The bright areas appear to be a coating of some nature, probably zinc (galvanised)**

**Figure 41, Similar to Figure 40, note the very irregular shape of some of the washers, indicated by arrows.**

**Figure 42, Similar to Figure 40**

Figure 43, Similar to Figure 40

Figure 44, Similar to Figure 40

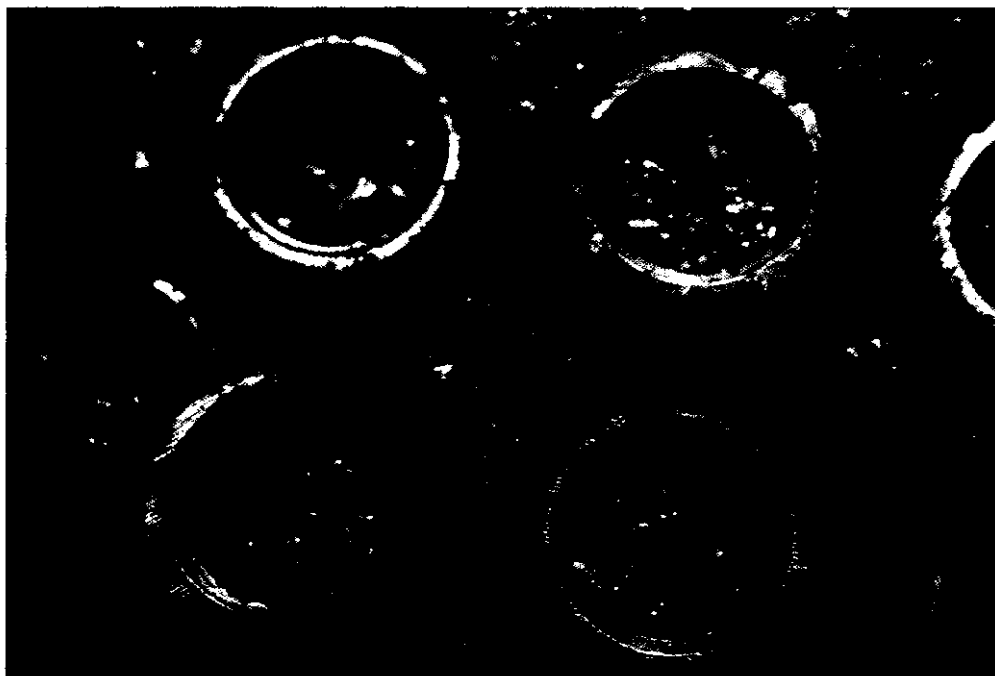
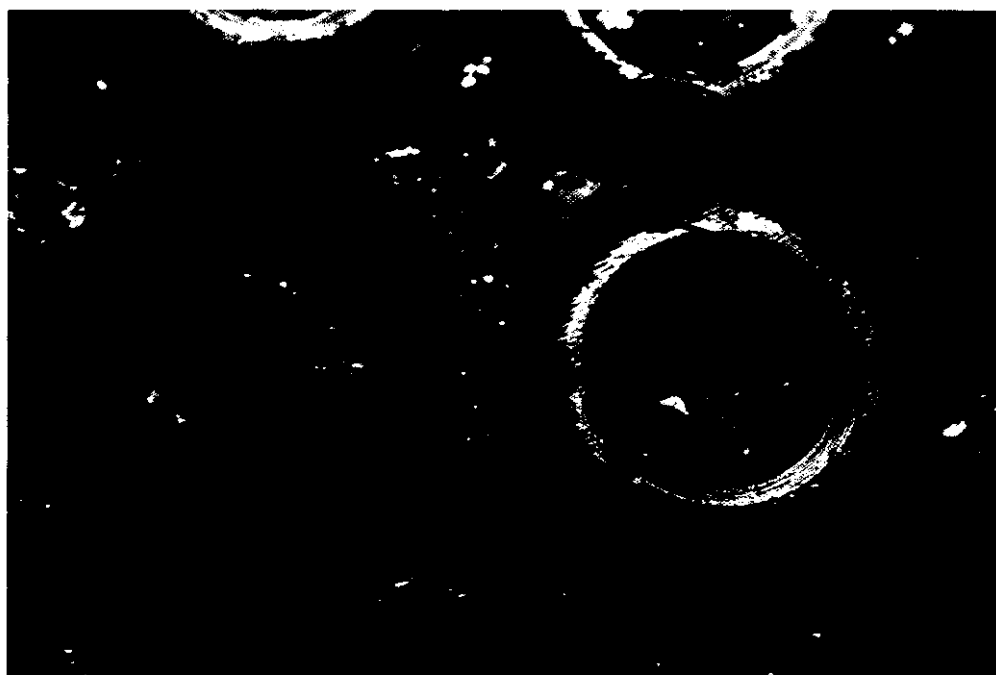
**Figure 45, Close-up view of some of the washer showing the very rusty contact surfaces and the irregular shape of some of the washers**

**Figure 46, Similar to Figure 45**

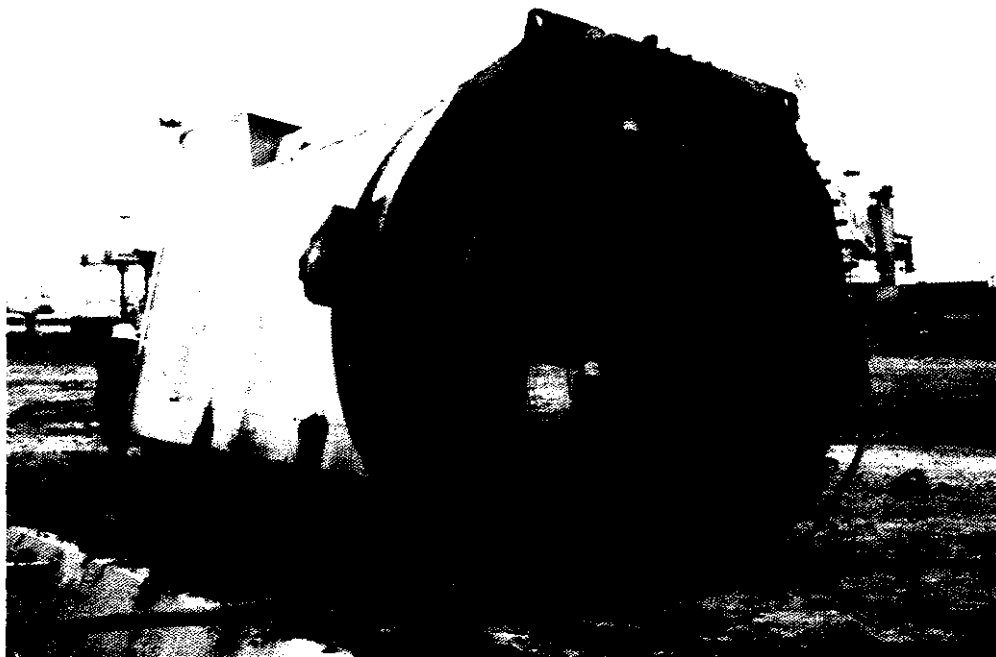
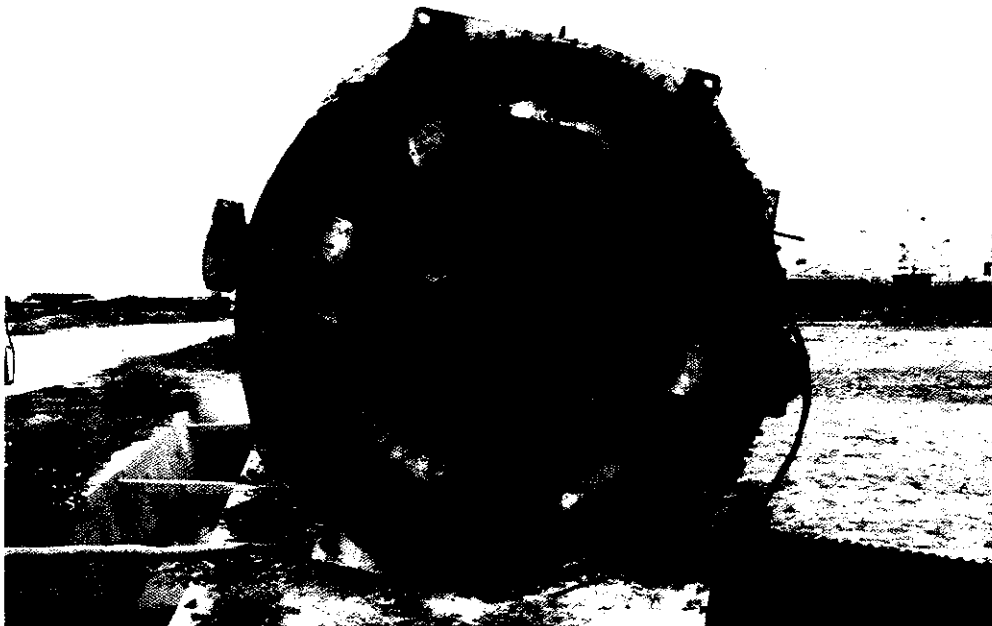
2.10.1 **Figures 49 to 51** show the crane tower after it had been taken ashore. At the time of collapse of the crane all seventy two (72) studs had remained attached to the tower. By comparison of this picture with that shown in **Figure 3** it may be seen that part of the outer slewing ring race had been removed and some of the studs had been flame cut. It later transpired that the engineering workshop dealing with the repairs to the vessel had removed part of the slewing ring in order to aid removal of the tower from the vessel.

**Figure 49, General view of the crane tower after removal from the Vessel. A majority of the outer slewing ring has been removed as well as some of the studs which had been flame cut**

Figure 51, End view of crane tower

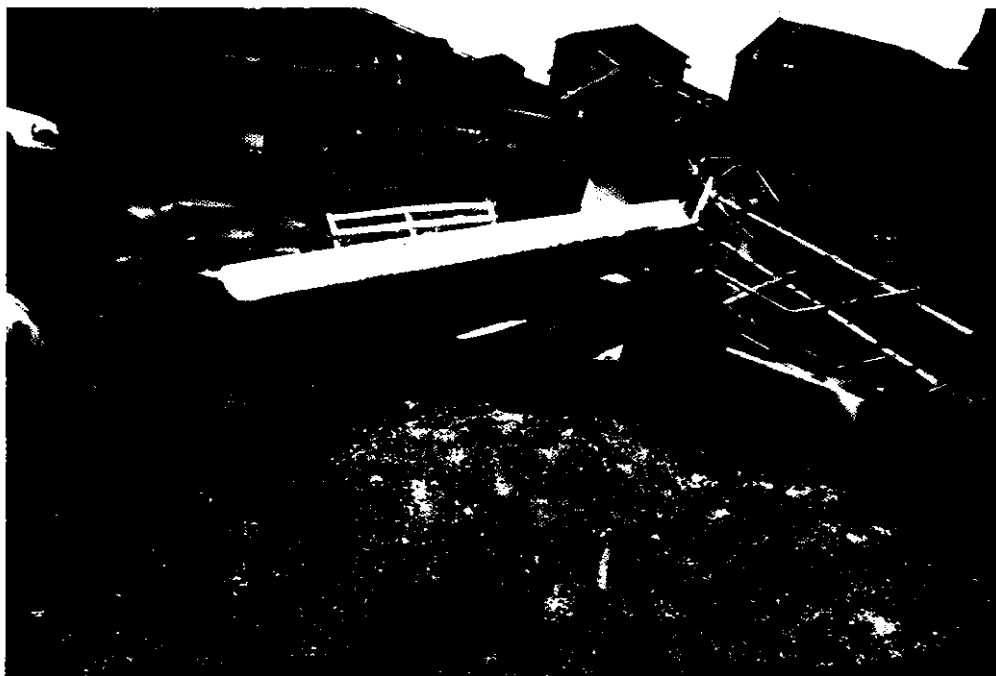
- 2.11.1 **Figure 61** shows two segments of the outer slewing ring race which had been burnt off by the repair team and discarded. Closer views of the underside are shown in **Figures 62 and 63**. The raised areas on the flange correspond to where the stud/nut/washer had been and the area between these raised areas corresponds to wastage of the flange.
- 2.11.2 The segment of outer slewing ring race that originally fractured at the time of the incident is shown in **Figures 64 and 65**. The fractured ends are shown in **Figures 66 and 67** (and also **Figures 7 and 8**). Both fractures were rapid, brittle type fractures consistent with high sudden loading. There was no evidence of any progressive or long mode of cracking such as fatigue cracking.

**Figure 61, General view of two segments of the outer slewing ring race discarded.**

**Figure 62, Closer view of one of the one of the outer slewing ring segments showing corroded surfaces**

**Figure 63, Close-up view of outer slewing ring race showing wastage either side of stud hole, the wastage has been indicated by arrows.**
